Technical Information

To : ICOM Distributors
From : ICOM Inc. / Export Department
Ref No. : SEN-014-03
Date : December 16, 2003

Re. Improvement of the PA Driver for the IC-703.

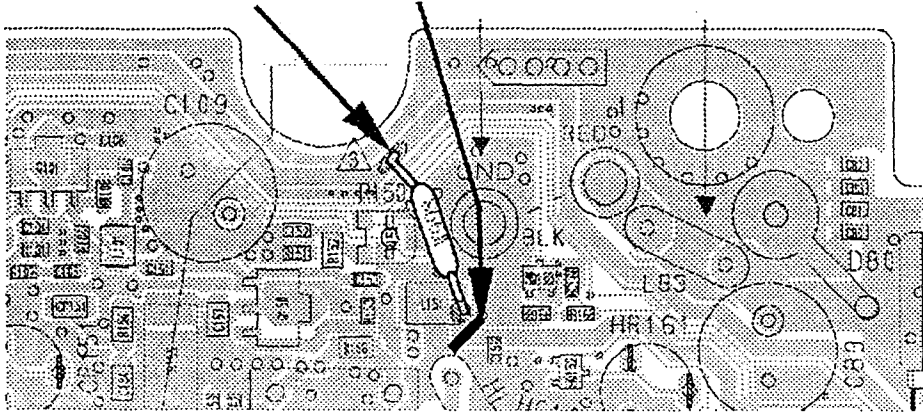
Parts Location on the MAIN board. (W998)

No RF power output.

The driver transistor (RD01MUS1) on the PA stage will be damaged when the transceiver is used in a high temperature environment.

For solution of this problem, we have reduced the current drain of the circuitry on the PA stage.

Solder the W998. Cut the PC trace on the MAIN board.
