Many Icom IC-703 radios have left the factory with the driver bias adjustment set excessively high. This may have caused many of the driver transistor failures in this radio. The following procedure allows users to set the drive transistor bias properly.

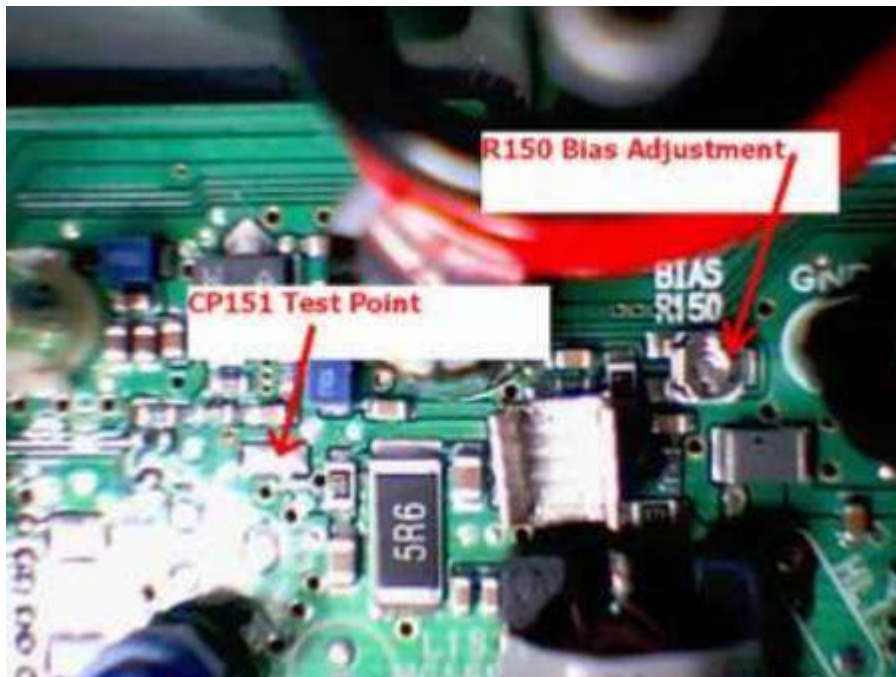
8. If the voltage rises much above .5 volts, readjust R150 for a reading of .5 volts. R150 is very small and requires a steady hand and a very small blade screwdriver. Very small movements make large differences. You will have two RF interconnect cables in your way (removed in the photo) over R150 you will have to work around.

6. Attach the positive lead of the digital voltmeter to CP151 Test Point (a square solder pad on the PC board).
7. Key the radio and observe the voltage reading. It will rise for a few seconds before stabilizing.
